Nelson City
Council
State of the
Environment
Report
2019–2023

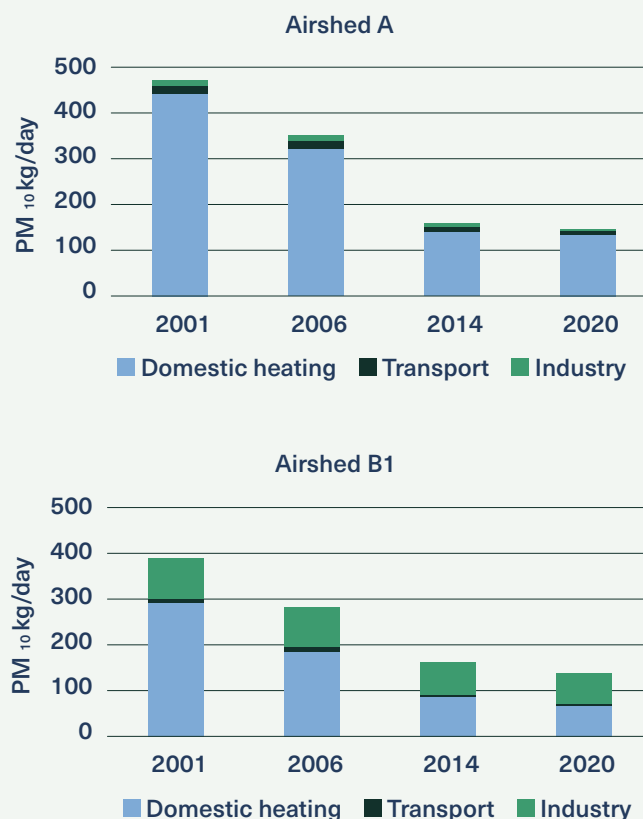
Graph 1: Shows the Improvement in Human Sources of PM10 Emissions by Source in Nelson South (Airshed A) and Tāhunanui (Airshed B1) from 2001 to 2020.

We undertook scientific studies to identify the causes and developed a strategy to reduce daily winter PM10 concentrations by around 70% in Nelson South (Airshed A) and 56% in Tāhunanui (Airshed B1) as shown in Graph 1. We also set a long-term air quality target of 32 µg/m³ for PM10 (66% of the NESAQ value). Domestic heating was identified as a key source of our daily winter PM10 and measures have been taken to improve this. Phasing out of open fires and older, more polluting, wood burners with clean heat or low emission alternatives has contributed significantly to improvements in our air quality. A ‘Clean Heat Warm Homes’ programme was established to assist low-income households

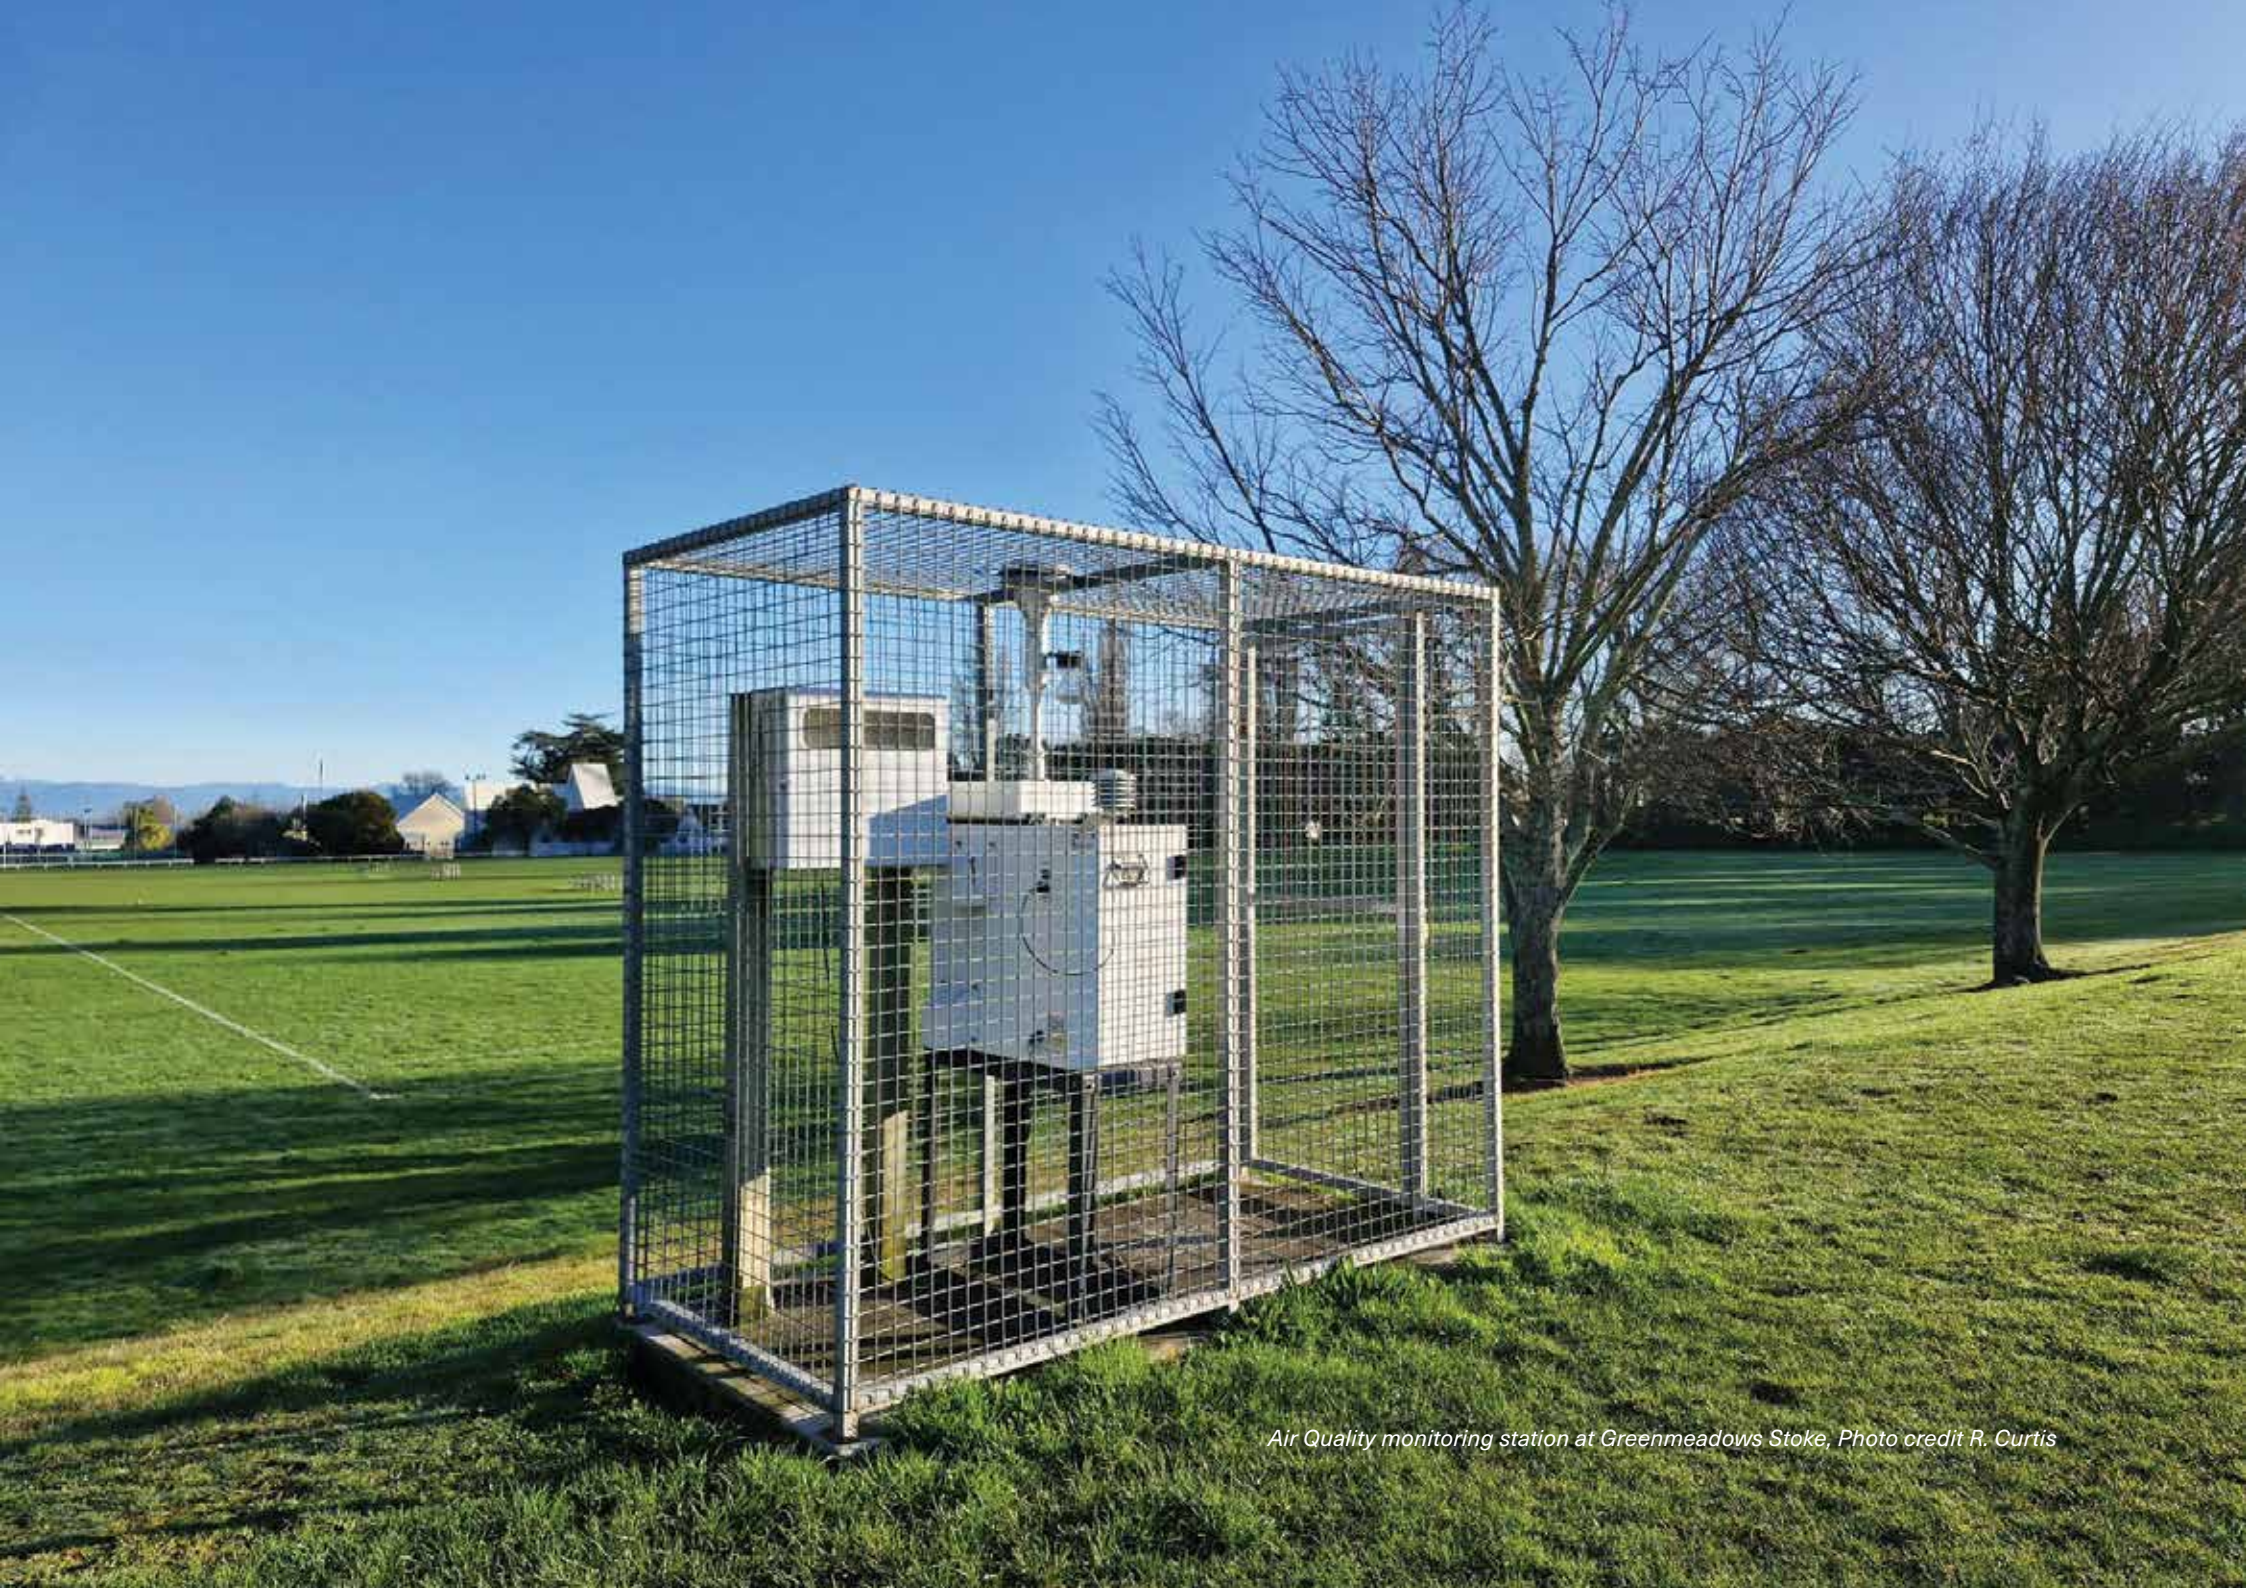
Air Quality monitoring station at Greenmeadows Stoke, Photo credit R. Curtis

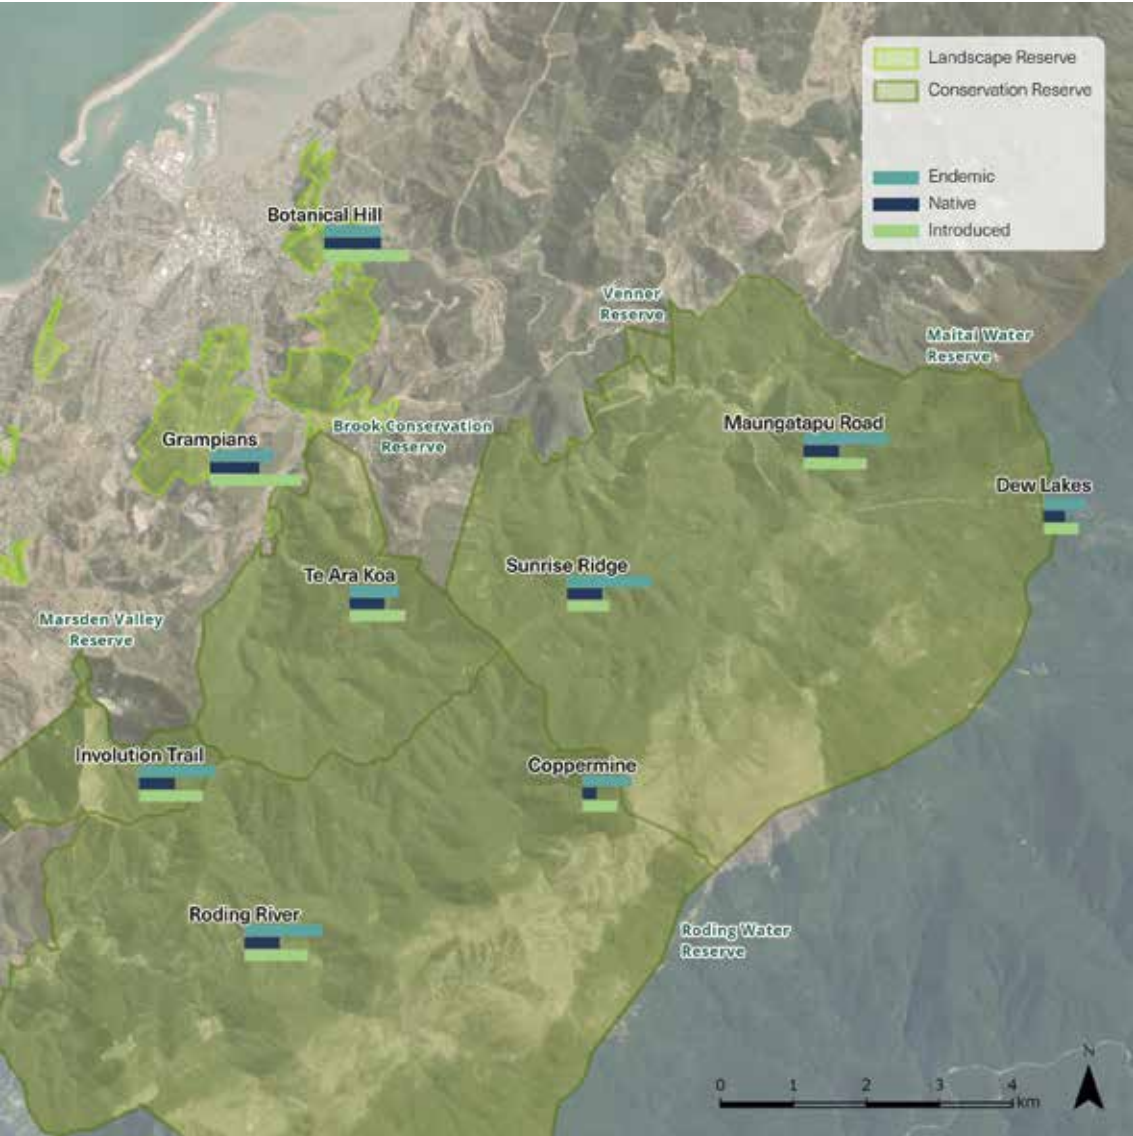
Figure 2: Bird Monitoring Survey Locations

The locations of the nine transects show the proportions of introduced, native and endemic bird species at each site. The size of individual bars is scaled to represent the total number of individual bird detections.

The numbers of endemic, native and introduced bird species heard or seen across the study area during the bird surveys varied considerably amongst the nine survey lines. The highest number of species (diversity) were observed in the Botanical Hill area (29 species) and southwest Grampians (28), and the lowest number of species were observed at the Coppermine and Dew Lakes (both 14).

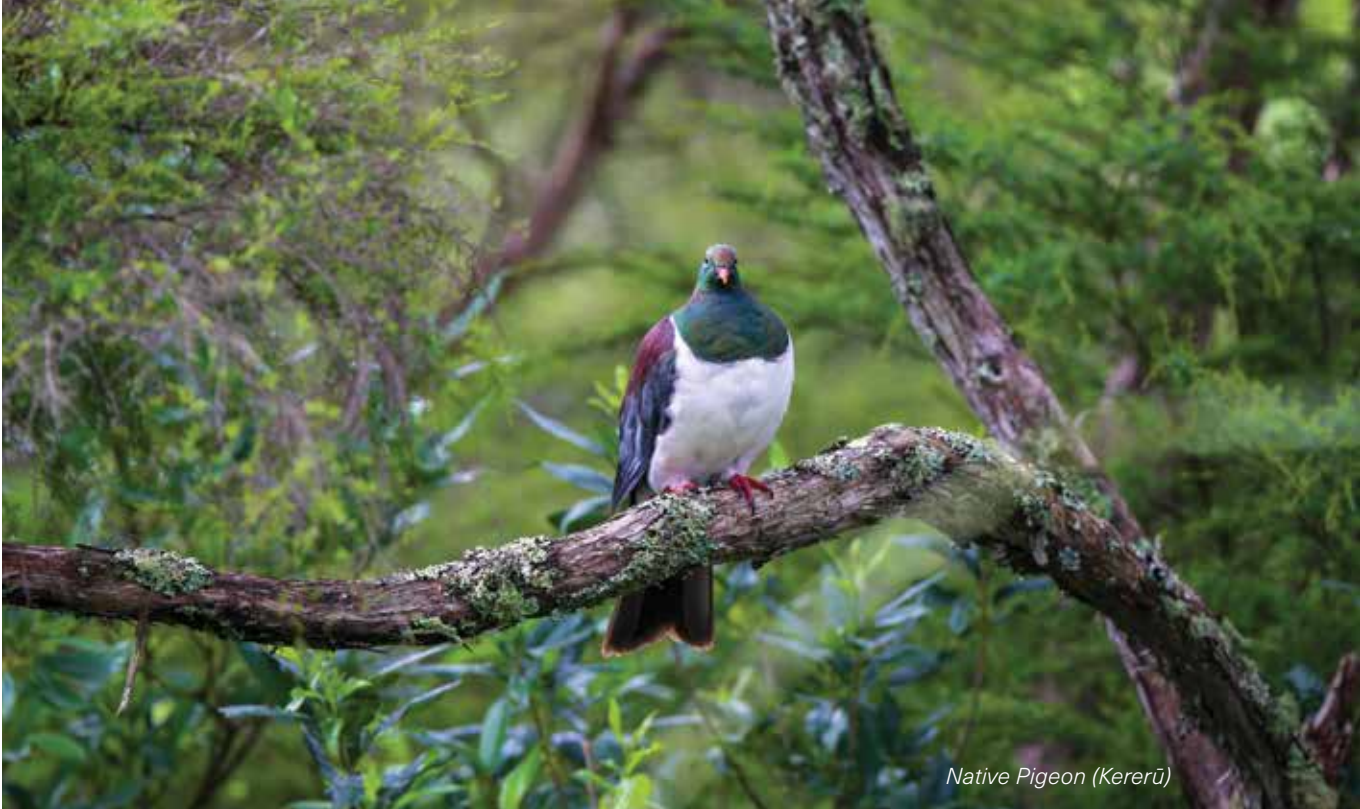
Graph 3: Bird Species Richness and Number of Observations

Of the 35 species observed in this study 13 were endemic, eight were native, and 14 were introduced (Graph 3).

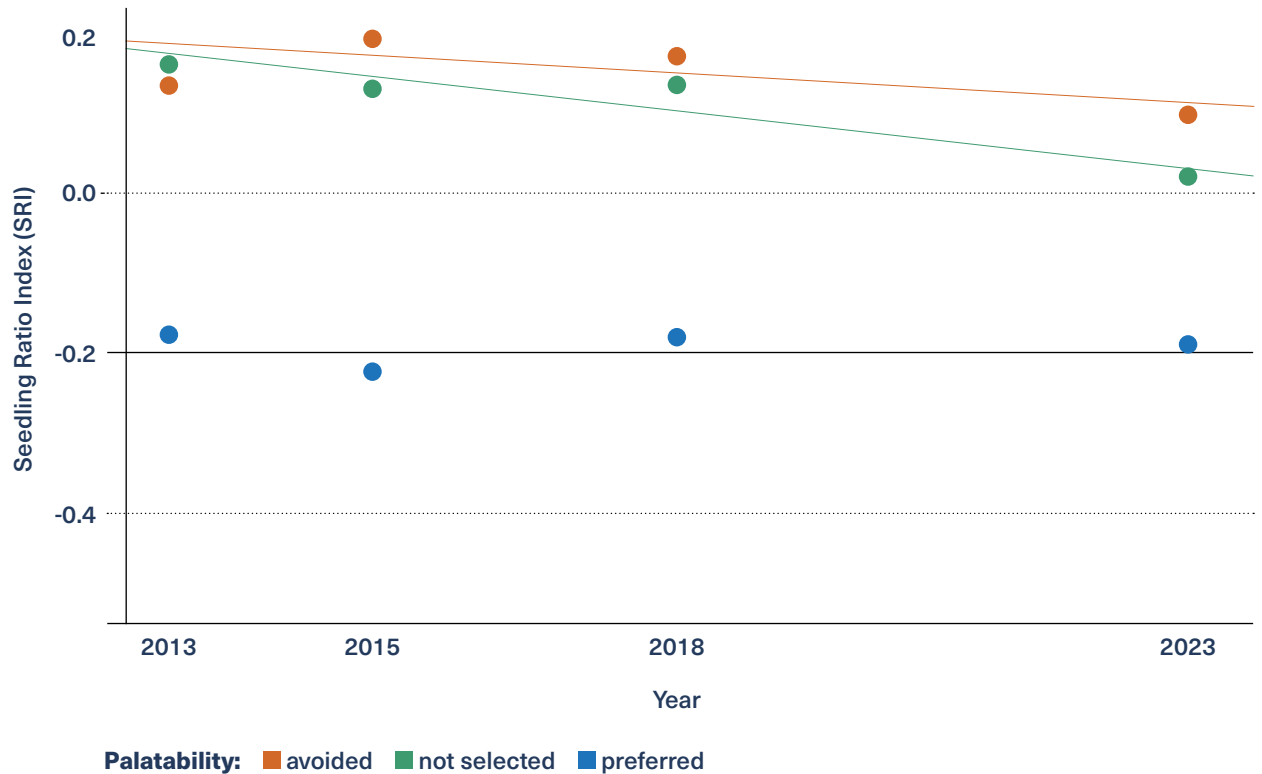
Graph 5: Average Seedling Ratio Index scores (SRI) for Dominant Woody Plants of Different Ungulate Palatability Classes in the Maitai and Roding Conservation Reserves, 2013 to 2023

The key results from this study demonstrate that the understorey of our forest ecosystems in our Conservation Reserves have already suffered noticeable damage from deer and goats in the 10 years since monitoring began. The extent of this damage has increased over time. Our monitoring also indicates that ungulates have reduced palatable vegetation to such low levels they now target less palatable vegetation (see Graph 5).

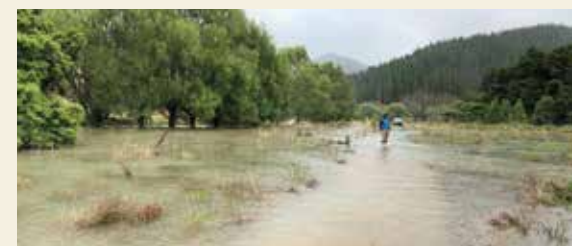
Picture 14: Flooded Planting Site August 2022

In August 2022 the project site was severely flooded (Picture 14), with many of the planted areas underwater for more than a day. Gravel and other flood debris buried plants and damaged fencing. Once the flood waters cleared, Nelson Marlborough Institute of Technology (NMIT) trainee Conservation Rangers and FuturEcology staff (a local conservation business) carried out a significant amount of work recovering the buried plants.

Many plants that would have otherwise been lost to the flood were recovered and the project now boasts a survival rate for its plantings of more than 90%, despite the flood damage. Other notable achievements include the establishment of a community nursery that has successfully supplied the project with some of its eco-sourced native seedlings, and construction of an access track that has allowed public access to over 1.5 km of the river. A trapping network is being established to control predators at the project site and to protect native wildlife, which is checked by volunteers and landowners.

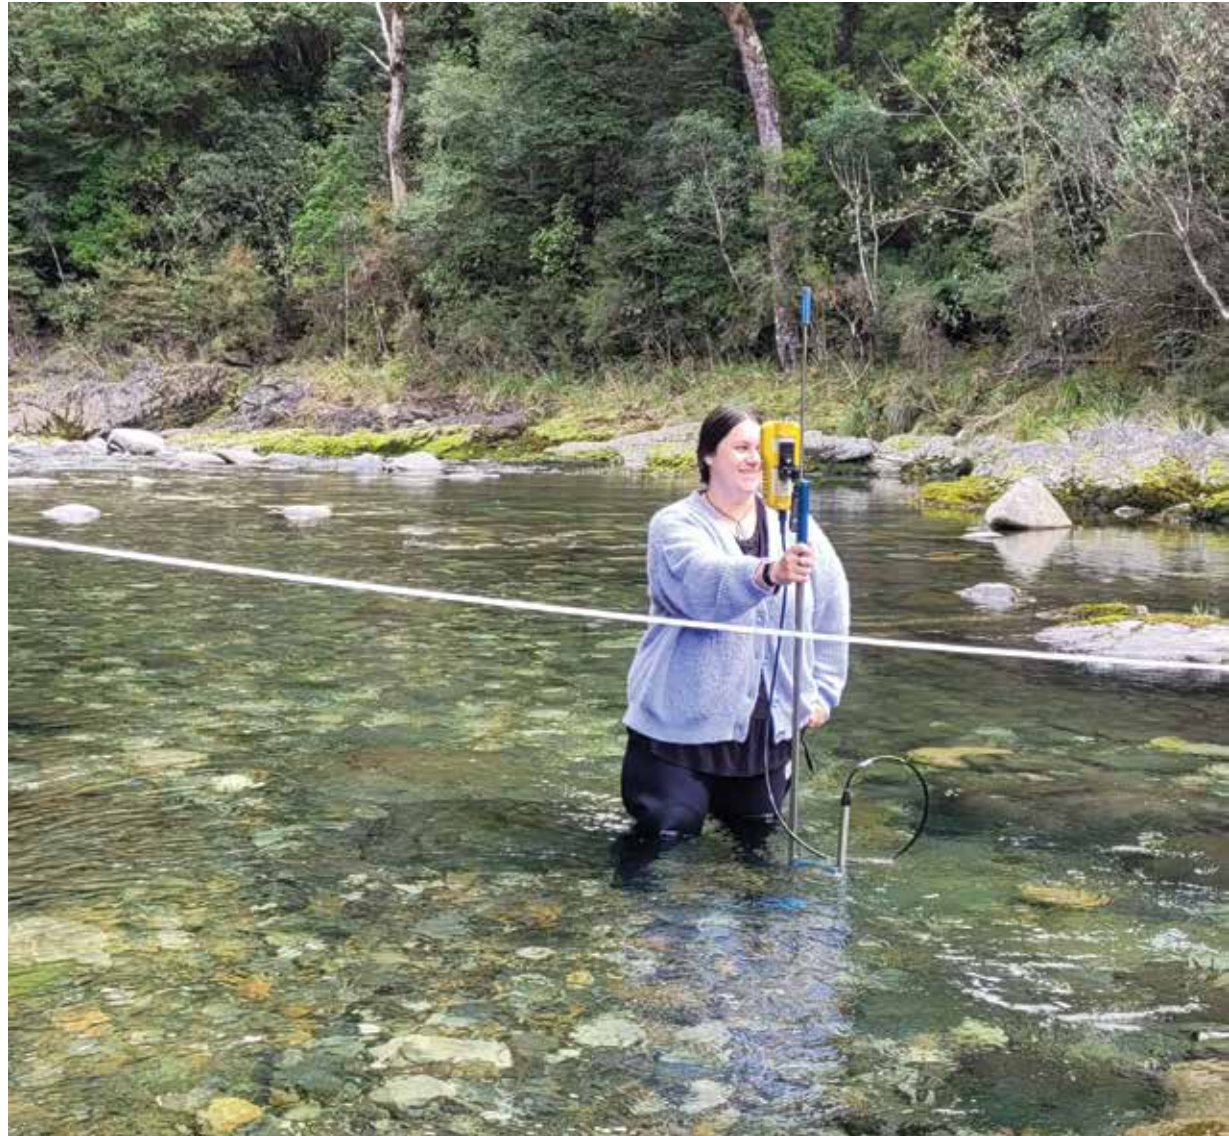
River Gauging on the Roding River. Photo credit M. Simpson

To make sure we are getting accurate readings from this monitoring, we visit the monitoring sites each month to physically measure the river flows. These gaugings show us the current flow in litres per second (l/s) or in cubic metres per second (m³/s) which we can compare to our long-term flow record to make sure it matches.

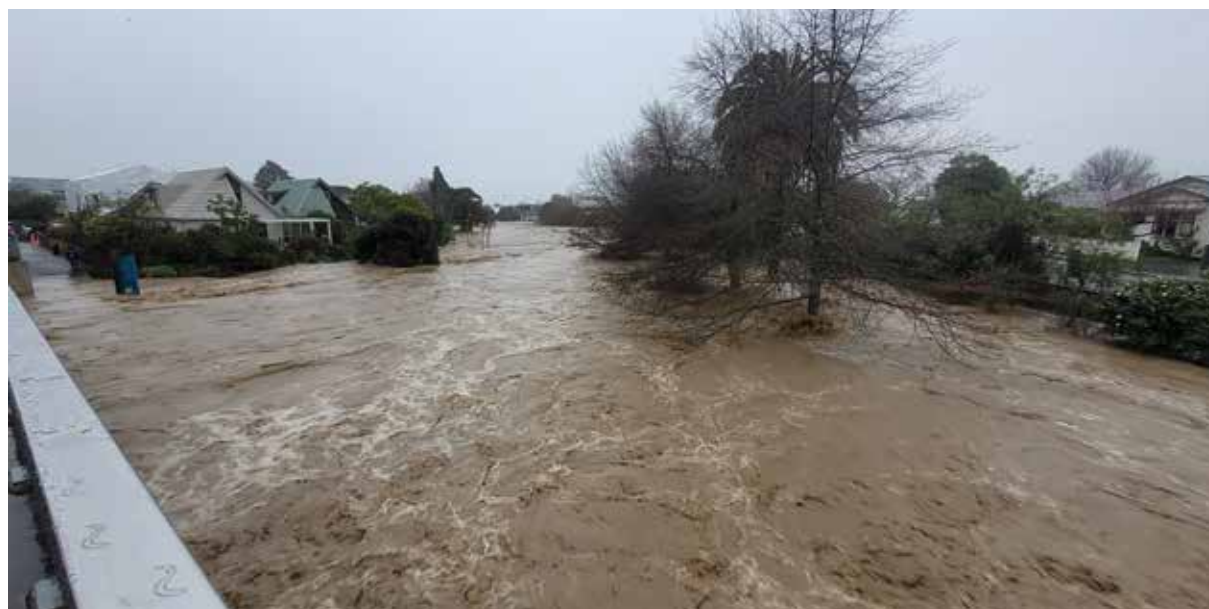
Picture 22: Maitai River in Flood During the August 2022 Storm Event

These were the catchments most exposed to the northerly rain. The rainfall was steady over an extended period rather than intense over a short duration. In the Maitai, this event closely resembles the 1970 and 1986 events, based on water level alone (See Picture 22.)

River site	First Peak (flow m3/s)	Second Peak (flow m3/s)	Third Peak (flow m3/s)	Estimated average recurrence interval (ARI)
Collins at Drop Structure	38	101	64	70+
Maitai South at Above Old Intake	73	52	51	15
Maitai at Forks	210	150	152	35+
Maitai at Avon Tce	322	304	267	35+
Orphanage at Ngawhatu	7.3	10.9	14.6	5
Wakapuaka at Hira	148	185	138	35+

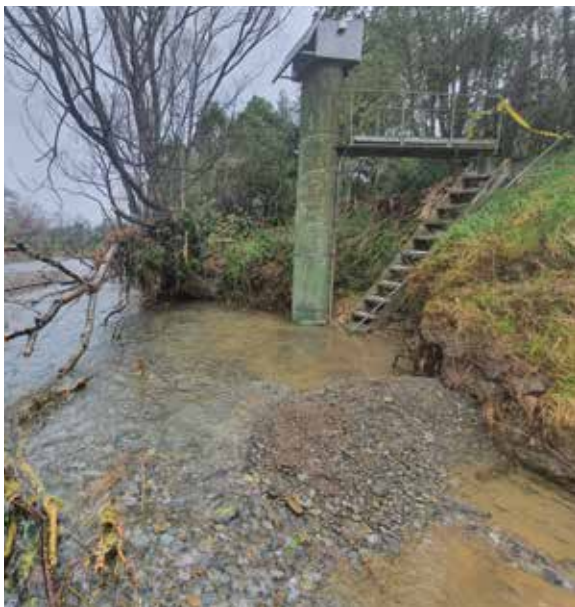
Picture 23: Wakapuaka at Hira After the August 2022 Flood. Photo credit NCC

Both recorder sites need to be repaired, if not replaced. (See Pictures 23 and 24.)

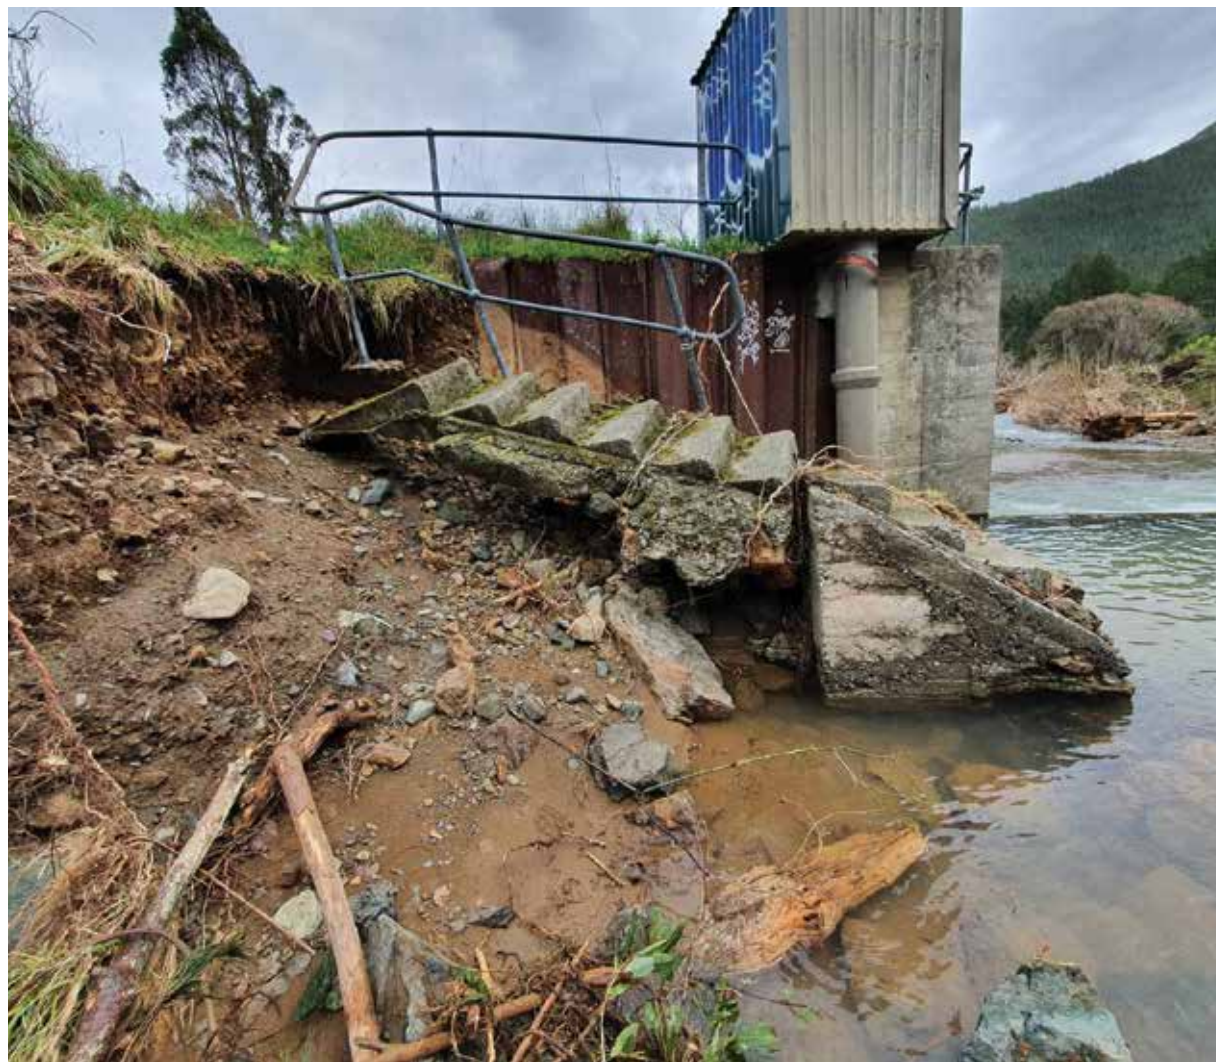
Picture 24: Collins at Drop Structure After the August 2022 Flood. Photo credit NCC

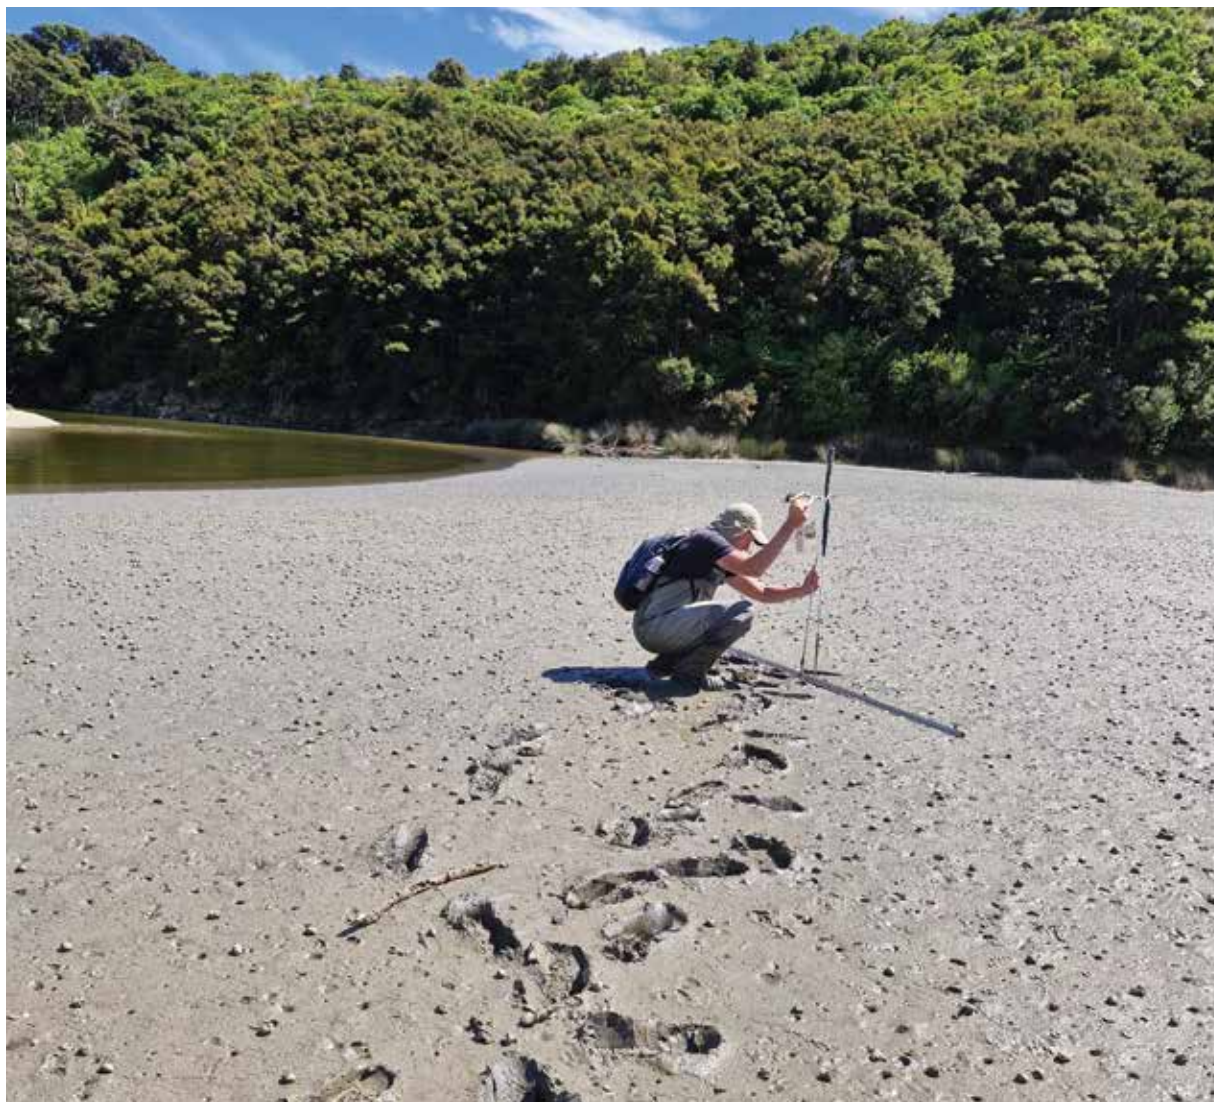
Picture 27: Measuring Sediment Plates in Kokorua Estuary. Photo credit P. Fisher

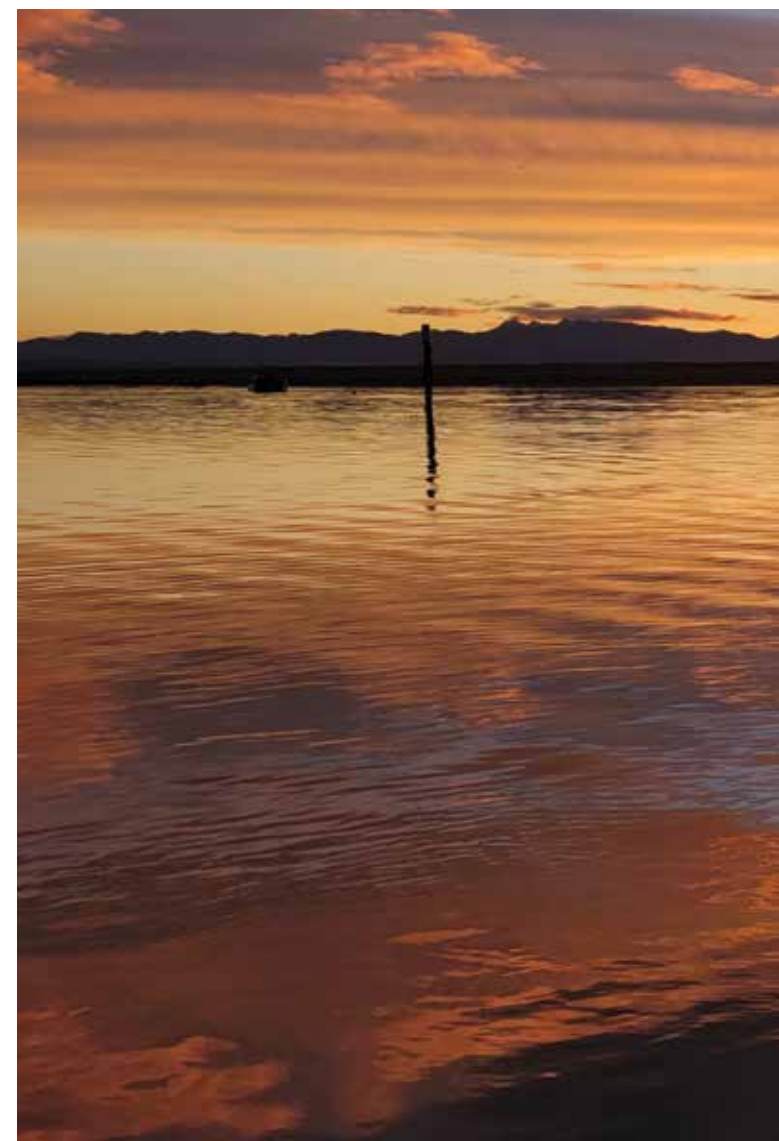
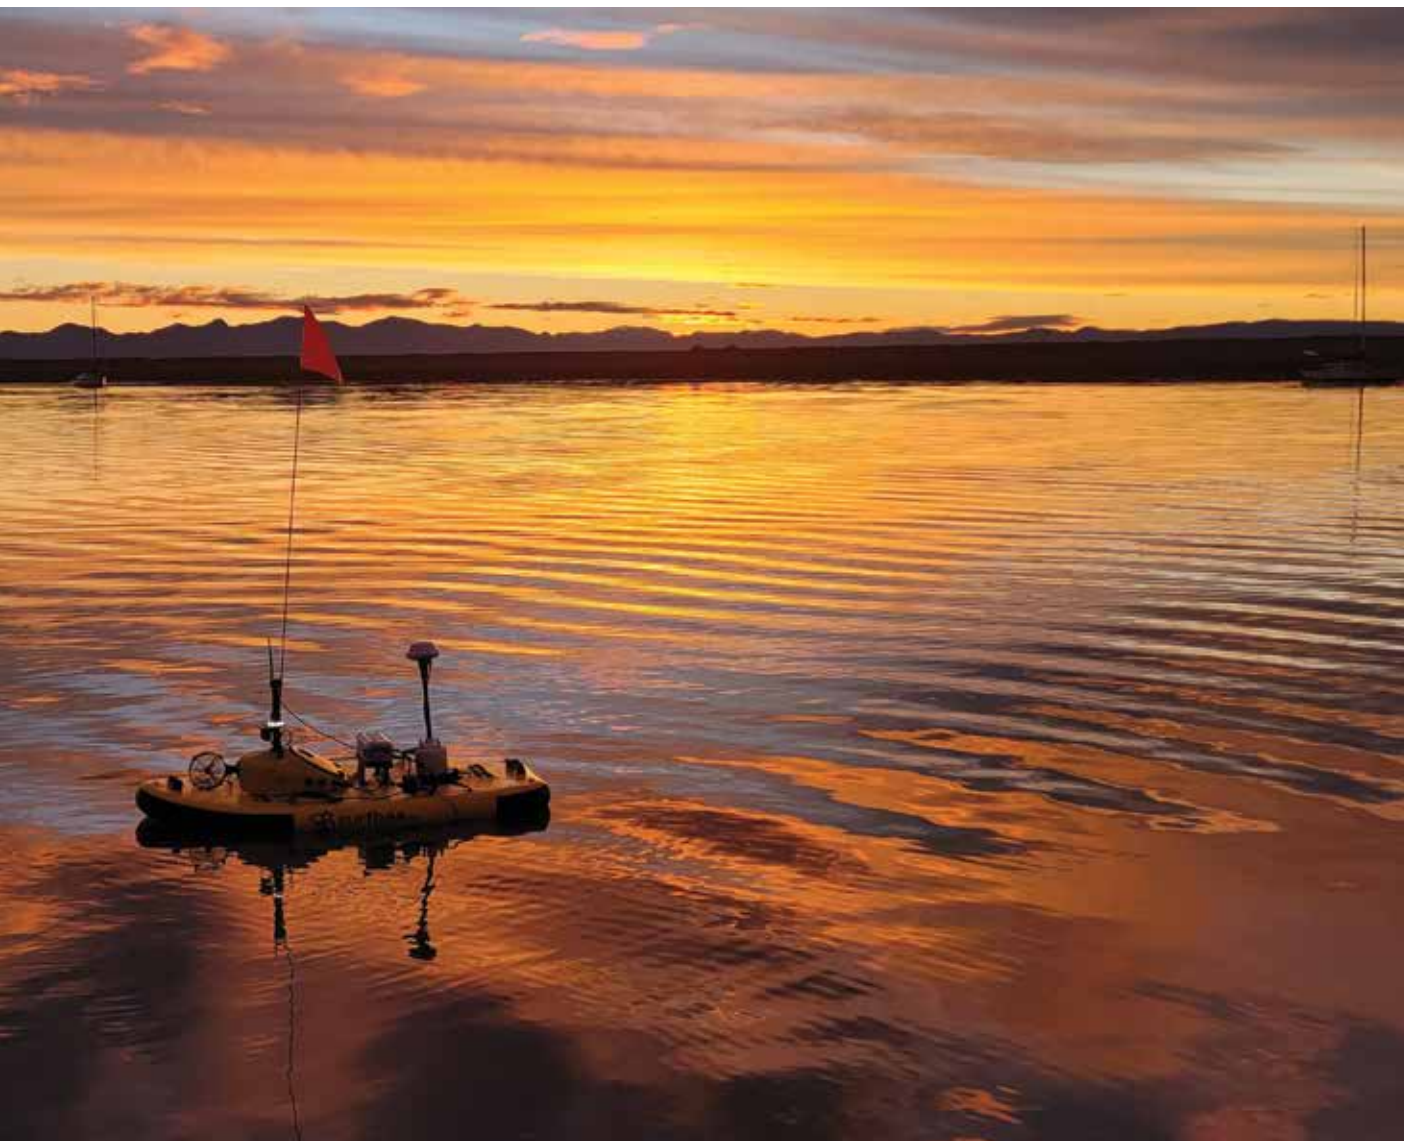
Picture 32: Collecting Tidal Water Movement Data to Build the Nelson Haven Sediment Deposition Model

To better understand the connectivity between Nelson Haven estuary and the surrounding catchment, we are developing a modelling tool that shows the transport of sediment and other river pollutants within the estuary's intertidal area. By linking catchment land use data and river load data to impacts in the estuary we can better predict how changes on land might impact our most vulnerable estuary habitats (Picture 32).
